Roanoke, Town of
(Thomas Feeney House)
Roanoke
Lewis County
West Virginia

HABS No. WV-209-I

WRITTEN HISTORICAL AND DESCRIPTIVE DATA

ROANOKE, TOWN OF
(Thomas Feeney House)

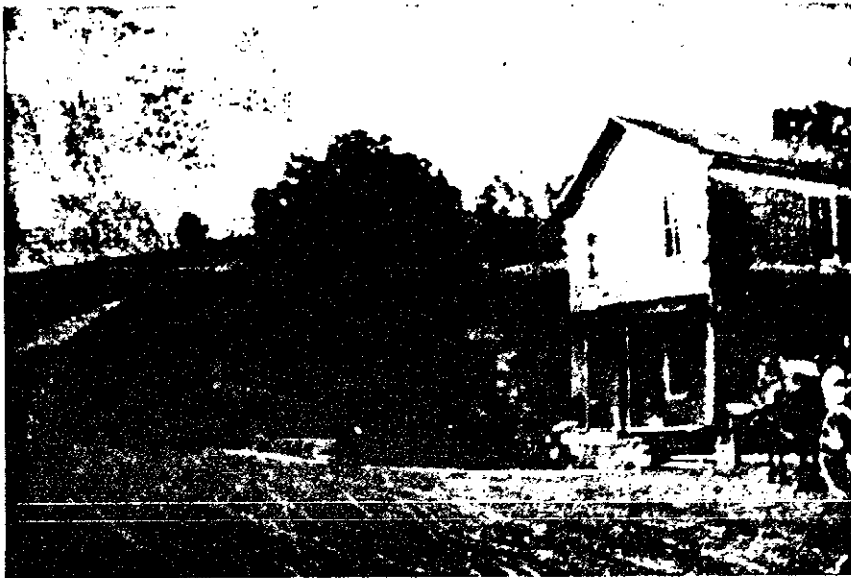
The Feeney store ca. 1928. Note the covered bridge over the West Fork River at left. The Feeney store sat approximately on the site of the present (1981) Roanoke U.S. Post Office. The Feeney dwelling is located to the right of the store out of this picture (James Whelan Photograph Collection).

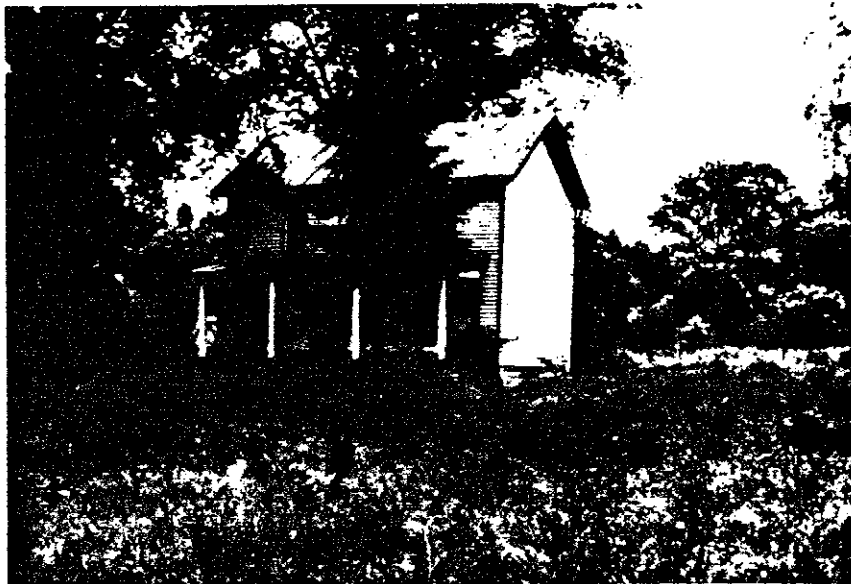
The east and north elevations of the Feeney dwelling in 1981. This photograph shows the general landscape near the structure. Note the large maple (Acer sp.) tree at left.

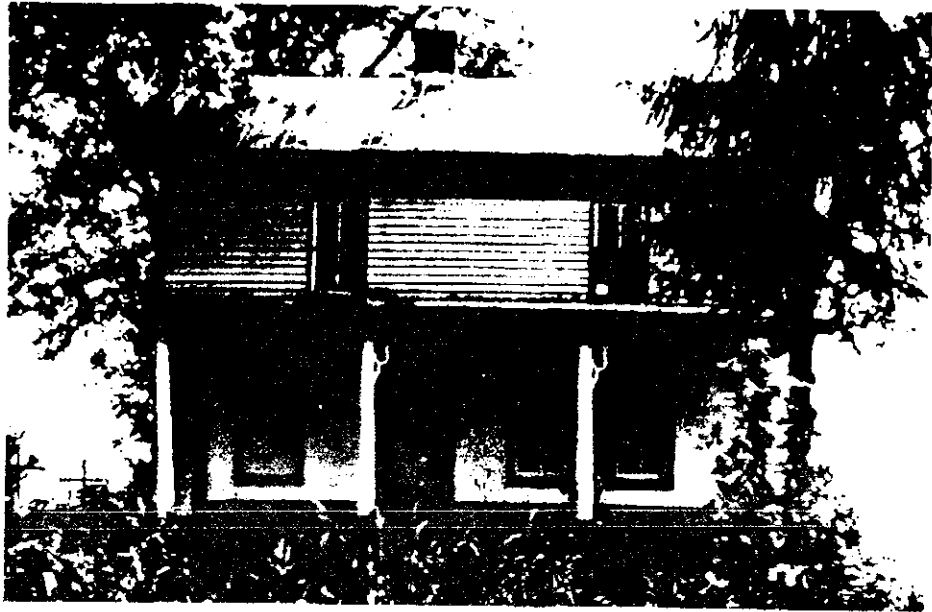
Perspective control photograph of the east elevation of the Feeney dwelling in 1981. Note the non-symmetrical positioning of windows in this elevation.

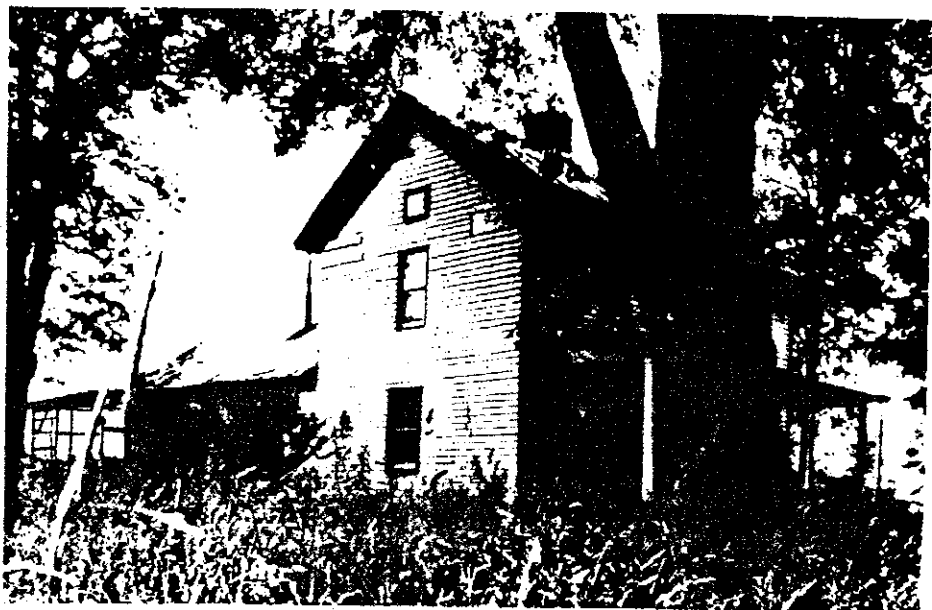
Perspective control photograph of the south and east elevations of the Feeney dwelling in 1981.

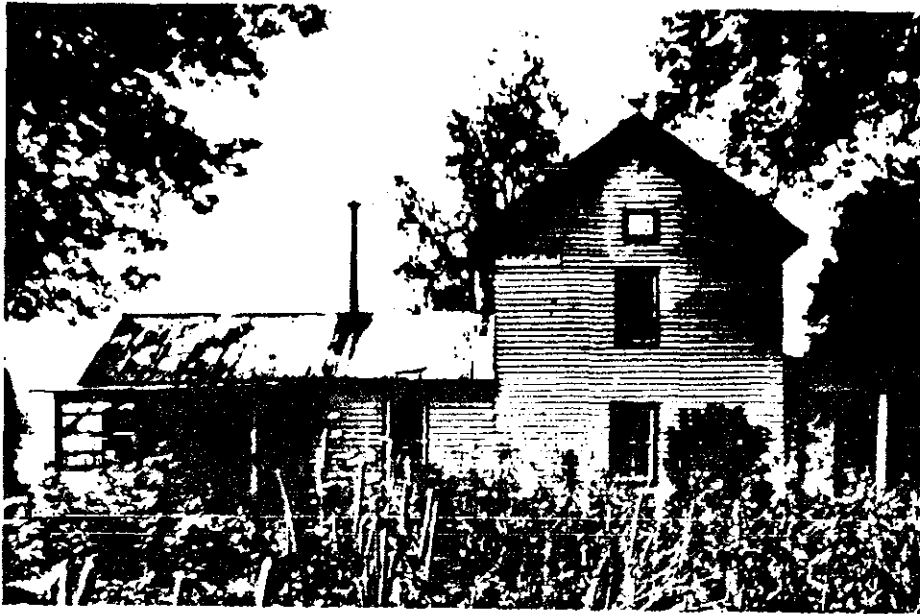
Perspective control photograph of the south elevation of the Feeney dwelling in 1981.

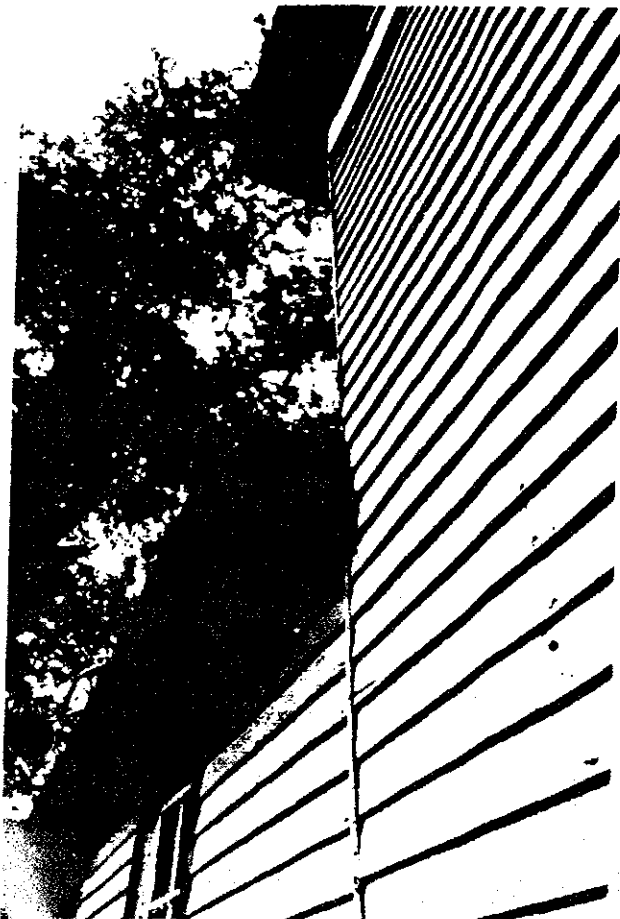
Close-up of boxed cornice eaves and frieze along the south elevation of the addition to the Feeney dwelling in 1981.

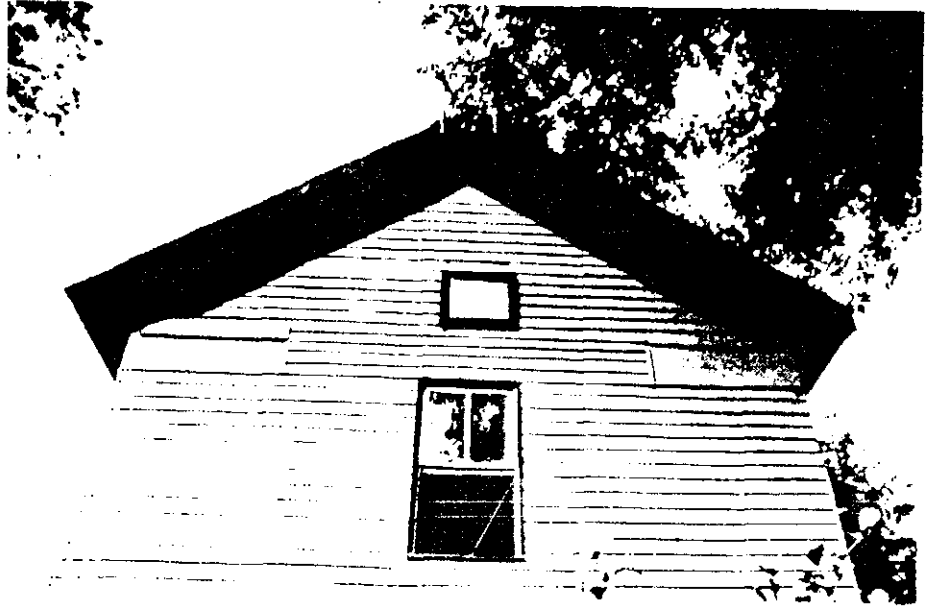
Close-up of boxed cornice and frieze raking trim on the south elevation of the Feeney dwelling in 1981. Note the partial return on the frieze.

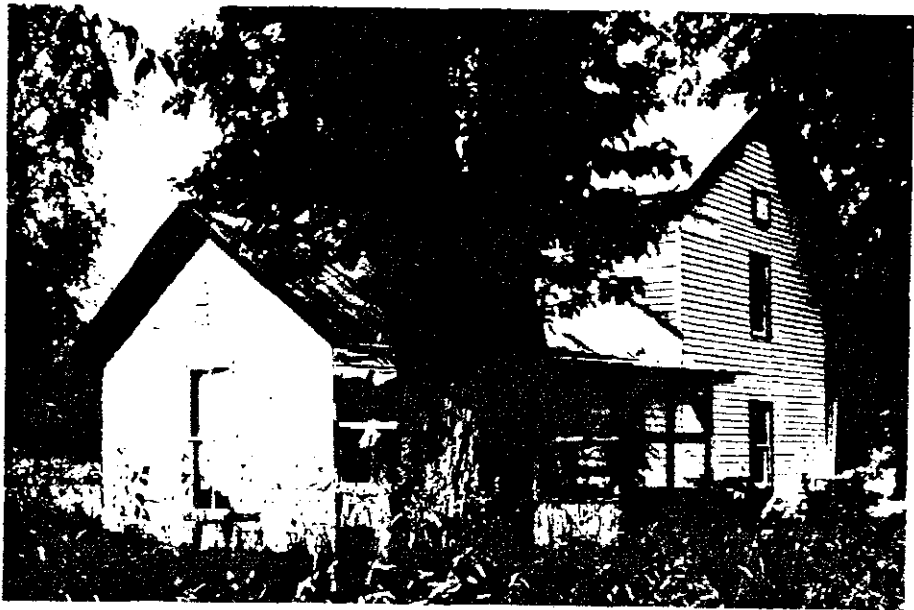
Perspective control photograph of the south and west elevations of the Feeney dwelling in 1981. Note the large maple (Acer sp.) tree at left.

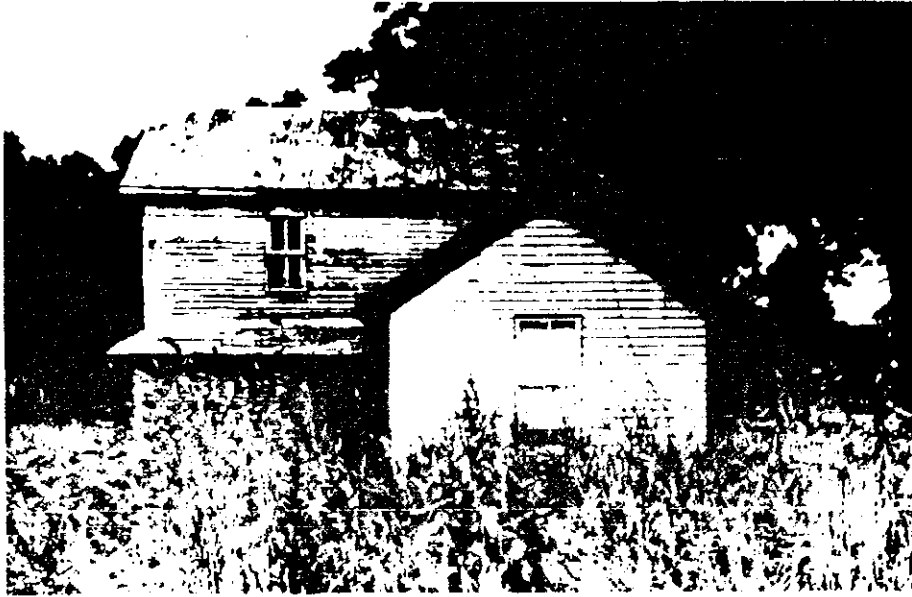
Perspective control photograph of the west elevation of the Feeney dwelling in 1981. This photograph clearly shows the relationship of the addition to the main portion of the structure.

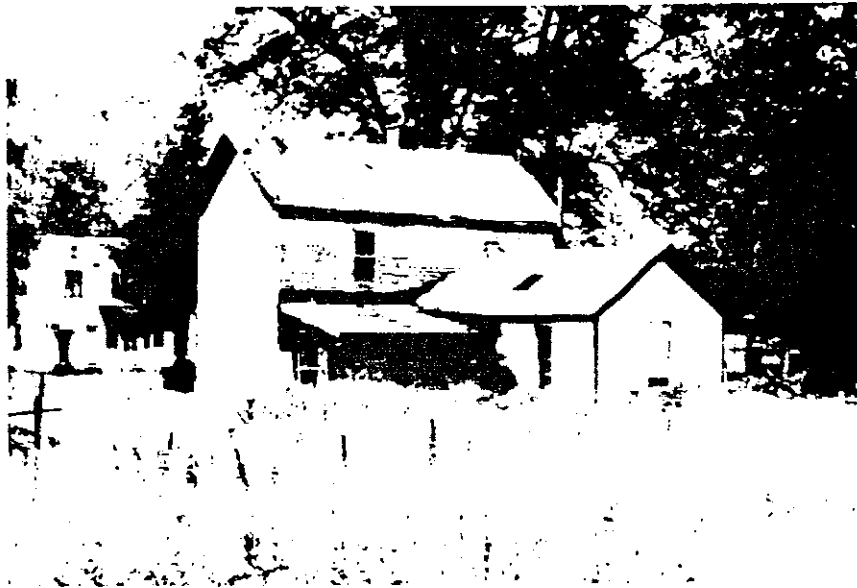
The west and north elevations of the Feeney dwelling in 1981. This photograph shows the general landscape near the structure. At left is the Whitesel store/Odd Fellows Lodge on Tract 1540.

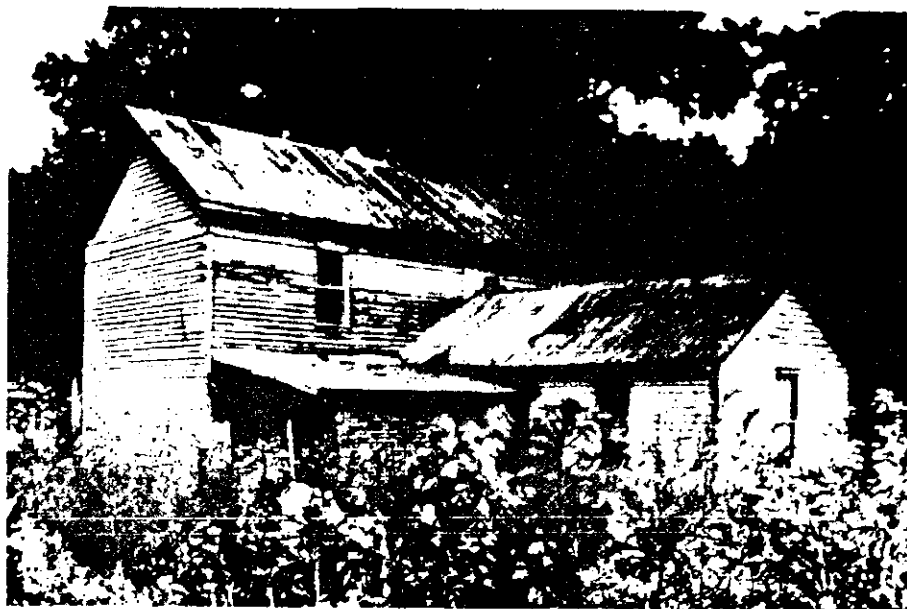
Chimneys: A stone chimney is centrally located on the roof peak of the original rectangular dwelling; a second chimney, consisting of a stove pipe, is located on the roof peak of the main addition and is offset toward the east.

Perspective control photograph of the west and north elevations of the Feeney dwelling in 1981. Note the corrugated sheet metal roof as well as the stone chimney centrally located on the roof peak.

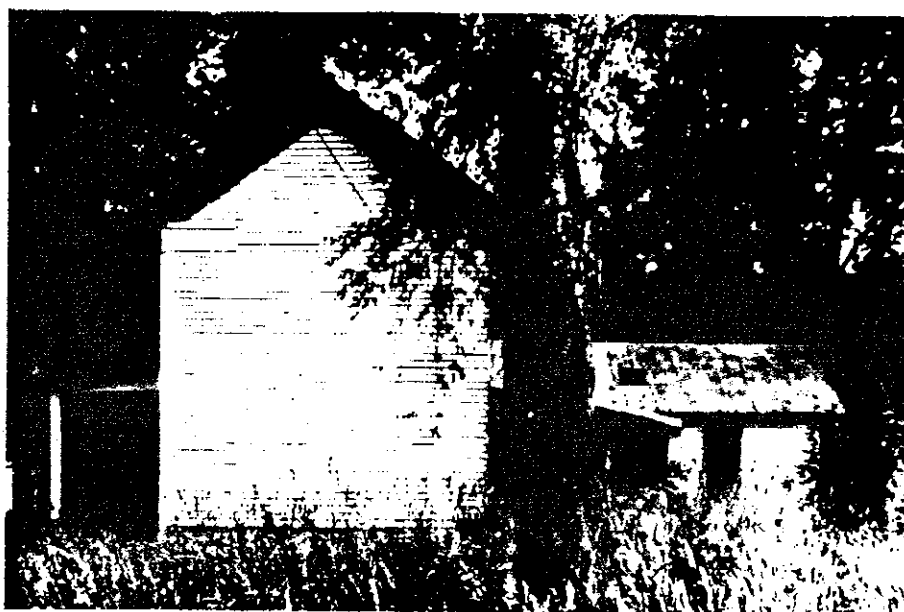
Perspective control photograph of the north elevation of the Feeney dwelling in 1981. Note the shed roof porch attached to the east elevation.

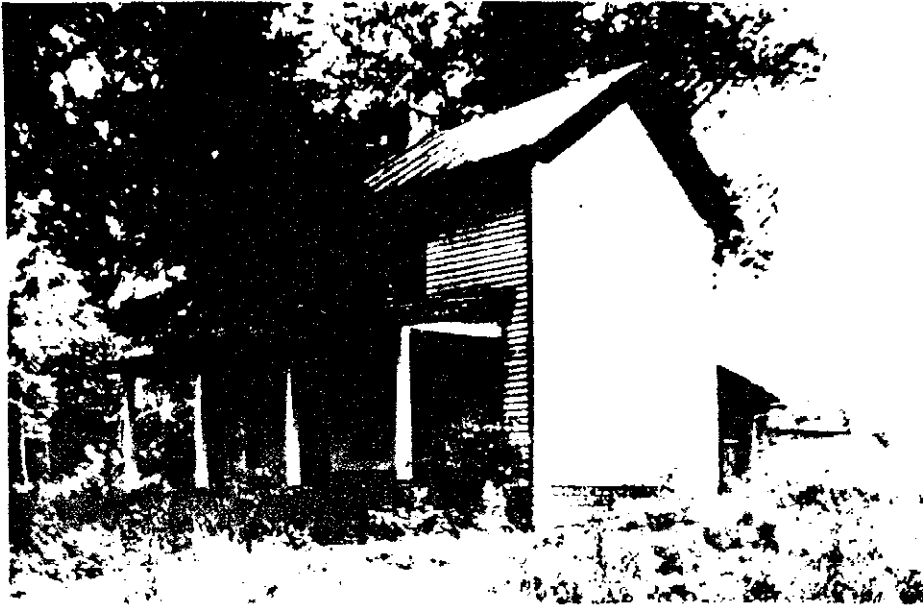
Foundation: The foundation of the Feeney dwelling consists of piers formed from a combination of square wooden blocks, piles of sandstones and round wooden posts. A rusticated, stone-impressioned sheet metal skirt encloses the foundation .

Perspective control photograph of the north and east elevations of the Feeney dwelling in 1981. Note the rusticated stone-impressioned sheet metal skirt around the foundation.

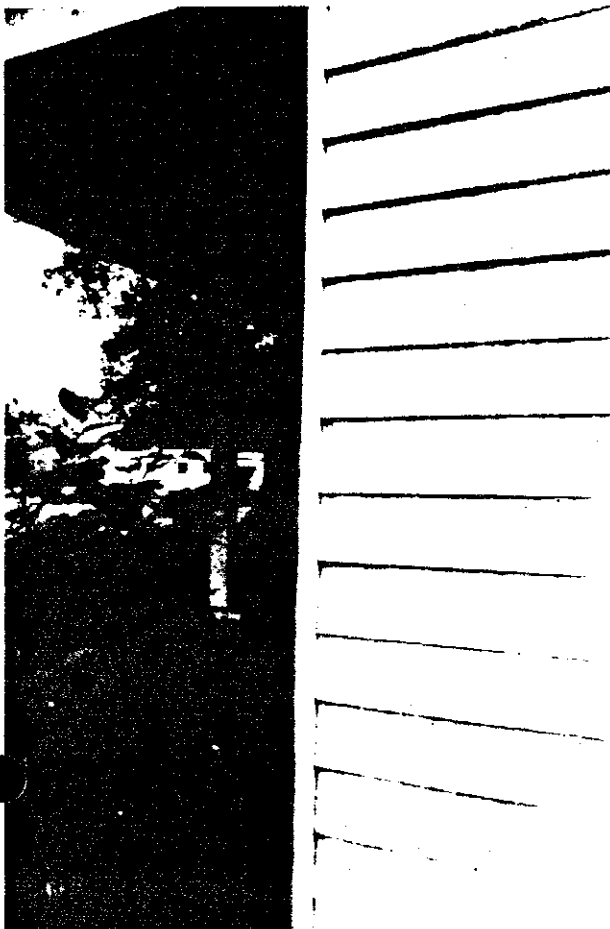
Walls: The walls are composed of 4 1/2" clapboards applied with cut nails; the clapboards are painted white; corner boards are painted deep red as is the window, door and roof trim.

Close-up of clapboards at the northeast corner of the Feeney dwelling in 1981.

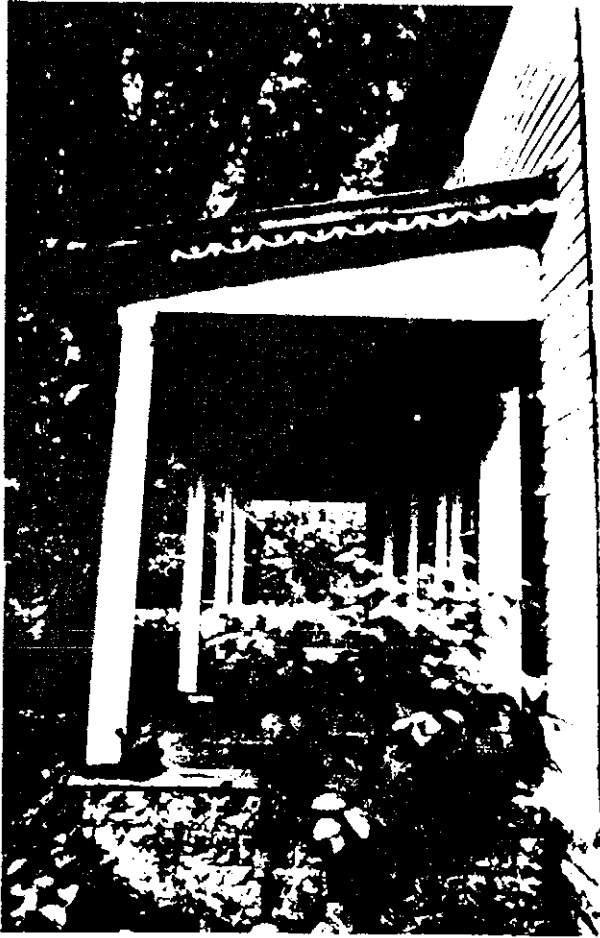
Close-up of shed roof porch attached to the east elevation of the Feeney dwelling in 1981. This view looks north to south. Note decorative barge board along raking trim.

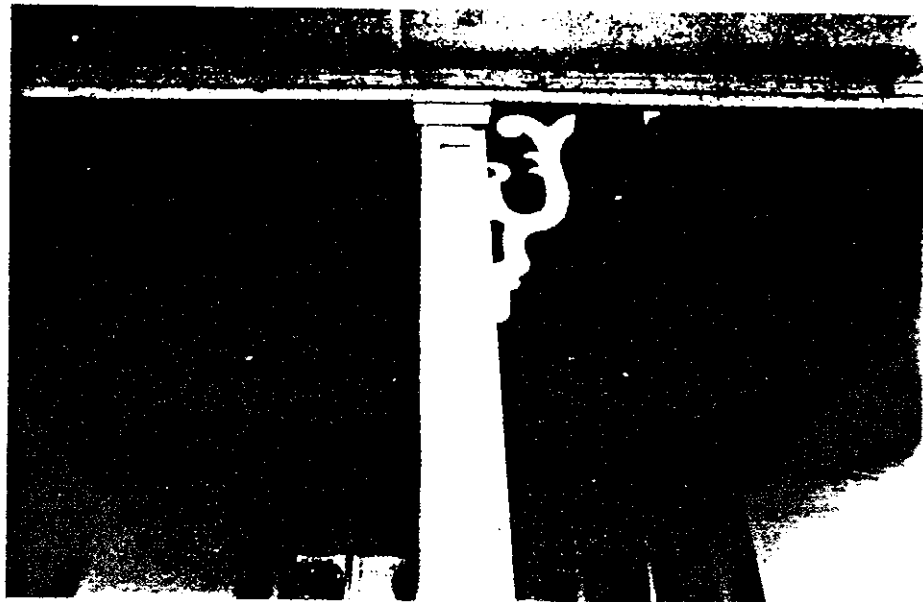
Porch: A porch which measures 7'2 3/4" wide x 26'1" long covers nearly the entire east elevation of the Feeney structure; the deck, which is raised 2' 1/2" above the ground, consists of 2 1/4" boards painted gray on wood joists and is supported on piers composed of piles of sandstone; the porch roof is covered by raised seam sheet metal roofing and is supported by four white 5 1/2" x 5 1/2" square columns with brackets; there is a 7 3/4" plain board baseboard painted gray at the base of the porch next to the house. The porch has an 8' ceiling consisting of 3 1/2" simple-beaded boards painted white; the deck is reached by ascending three concrete steps (50" wide x 11 1/2" tread x 8" high) plus an 8" riser.

Close-up of column and bracket of porch on the east elevation of the Feeney dwelling in 1981.

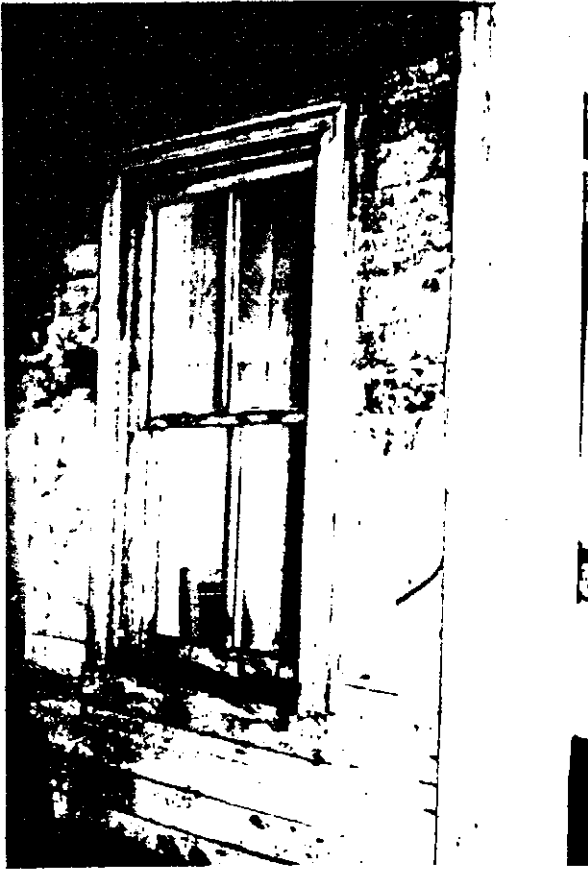
Close-up of the north 2/2 window in the east wall of Room 1 of the Feeney dwelling in 1981. The clapboard siding clearly demonstrates that this was once an exterior wall of the structure.

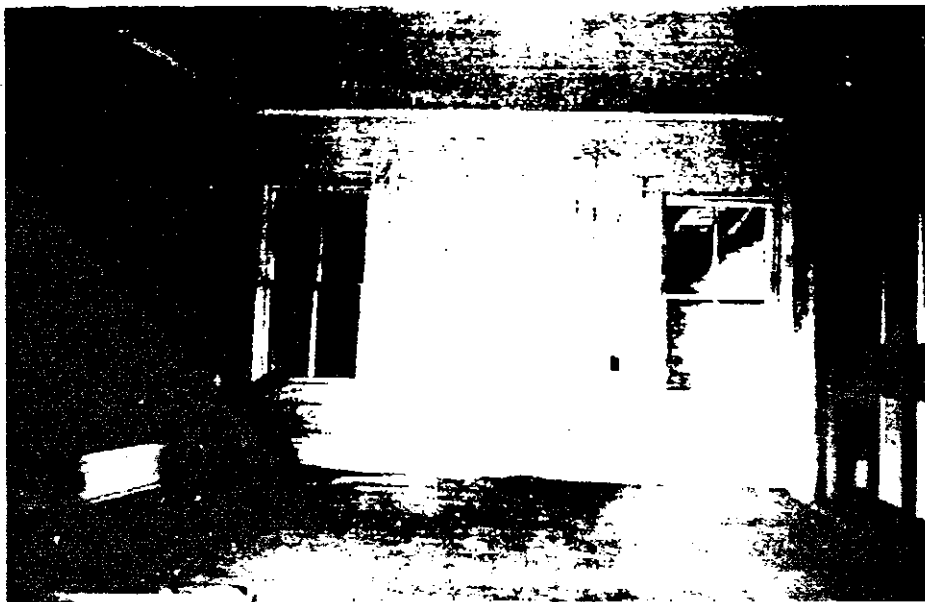
West wall of Room 2 of the Feeney dwelling in 1981. This photograph indicates how little modification was done to the west elevation of the original structure when the Room 1 addition was added.

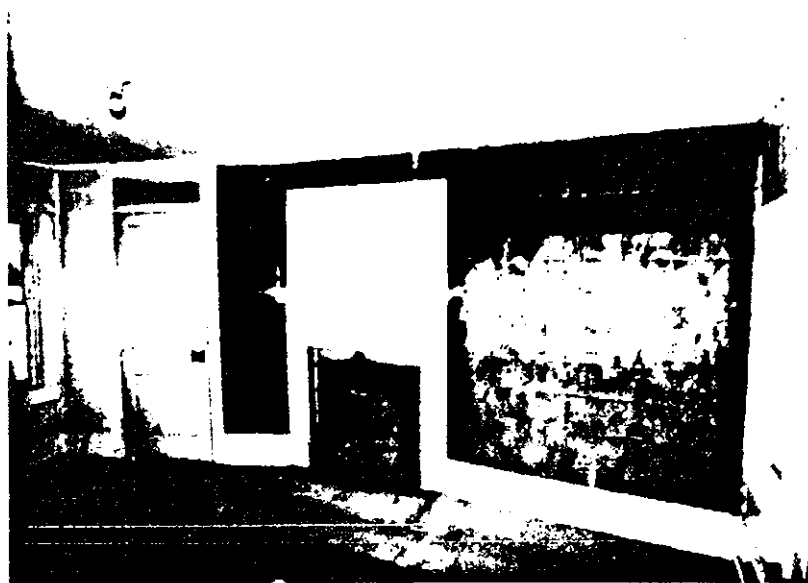
South wall of Room 2 of the Feeney dwelling in 1981. The door to Room 3 (hallway) is at left. Note the horizontal board wall composed of different width boards to the left and right of the fireplace.

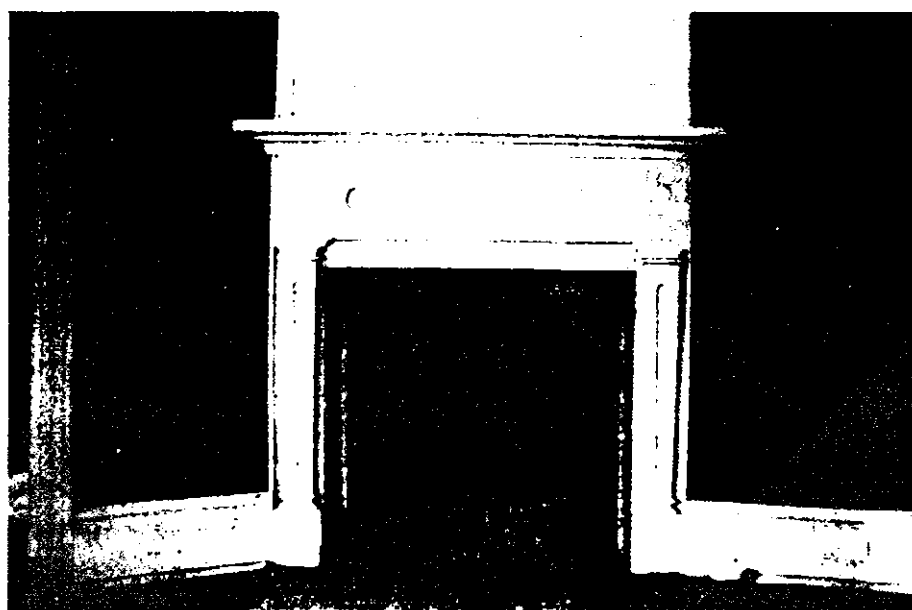
Fireplace: brick; 1'11 1/2" x 4'4" concrete hearth; wooden mantle.

Close-up of fireplace and mantle in Room 2 of the Feeney dwelling in 1981.

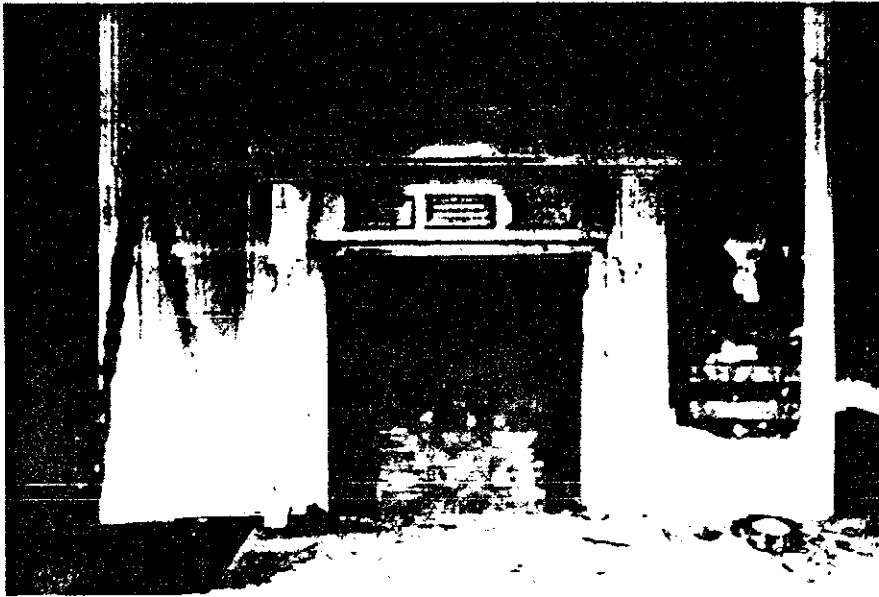
Fireplace: brick; 1'10 1/2" x 4'5" concrete hearth; wooden mantle .

Close-up of fireplace and mantle in Room 4 of the Feeney dwelling in 1981.
Contrast this mantle with that in Room 2 (Figure 274).

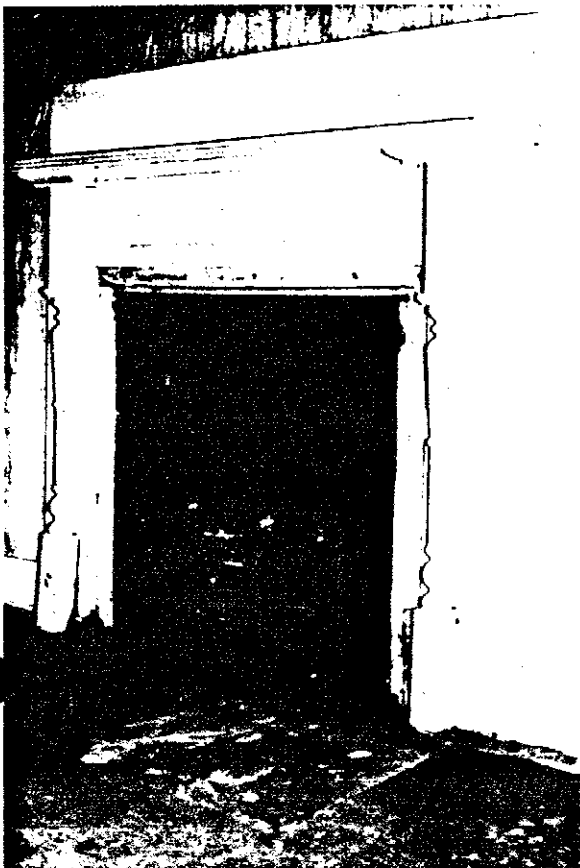
Close-up of fireplace and
mantle in Room 4 of the Feeney dwell-
ing in 1981.

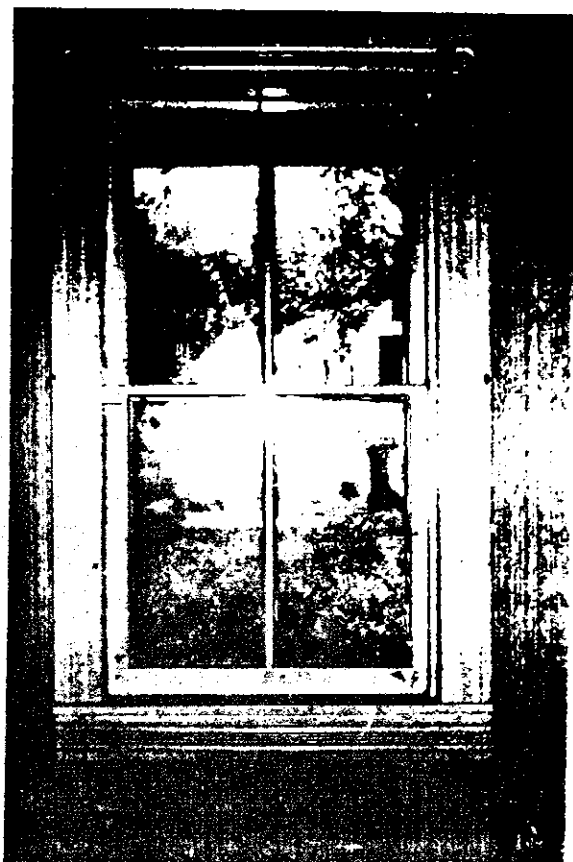
Close-up of 2/2 window in east wall of Room 4 of the Feeney dwelling in 1981. Note the ornate corner blocks and surround trim.

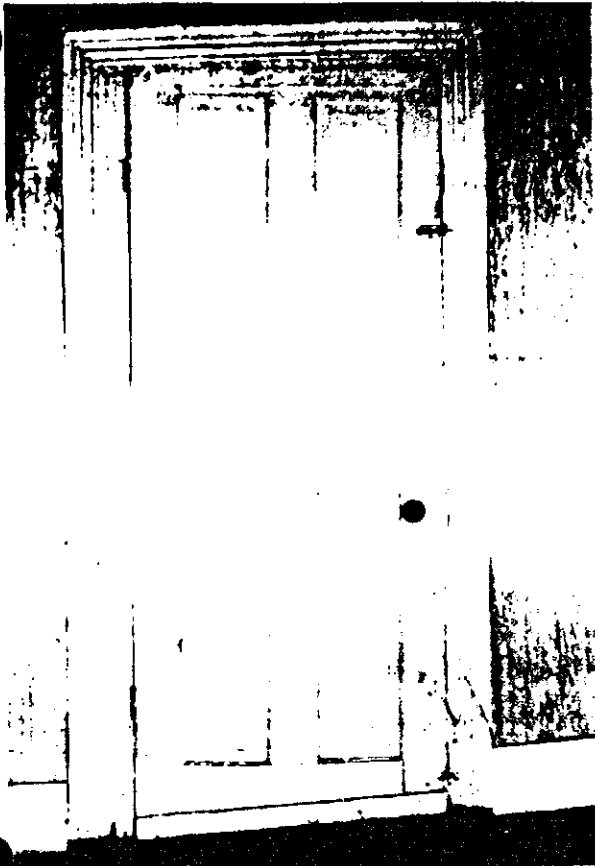
Close-up of Room 1 to
Room 5 door from Room 5 in the
Feeney dwelling in 1981. Note the
bottom of the door.

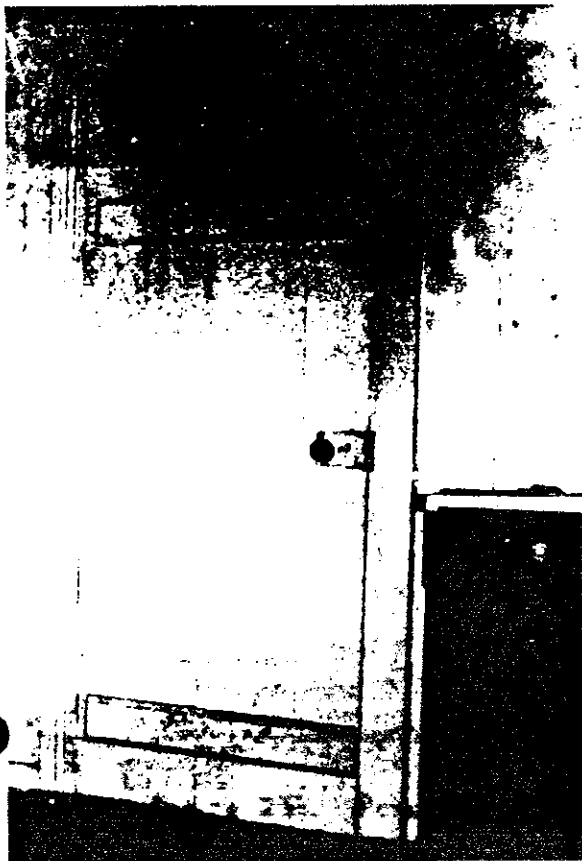
Close-up of Room 6 to
exterior board and batten door in the
Feeney dwelling in 1981.

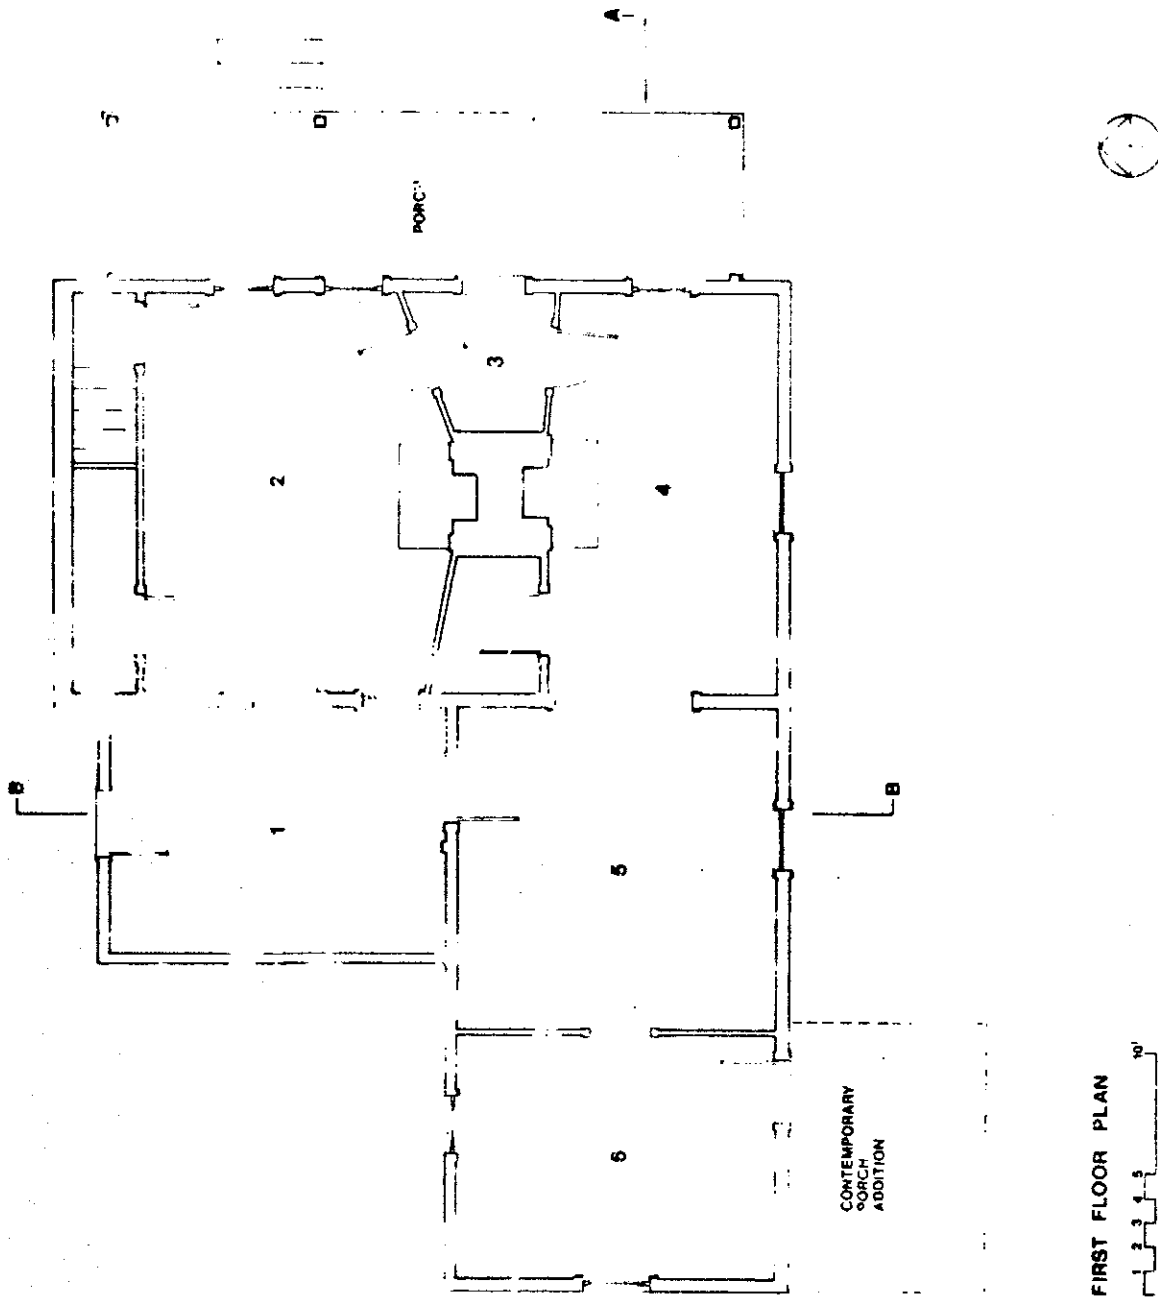
First floor plan of the Feeney dwelling.

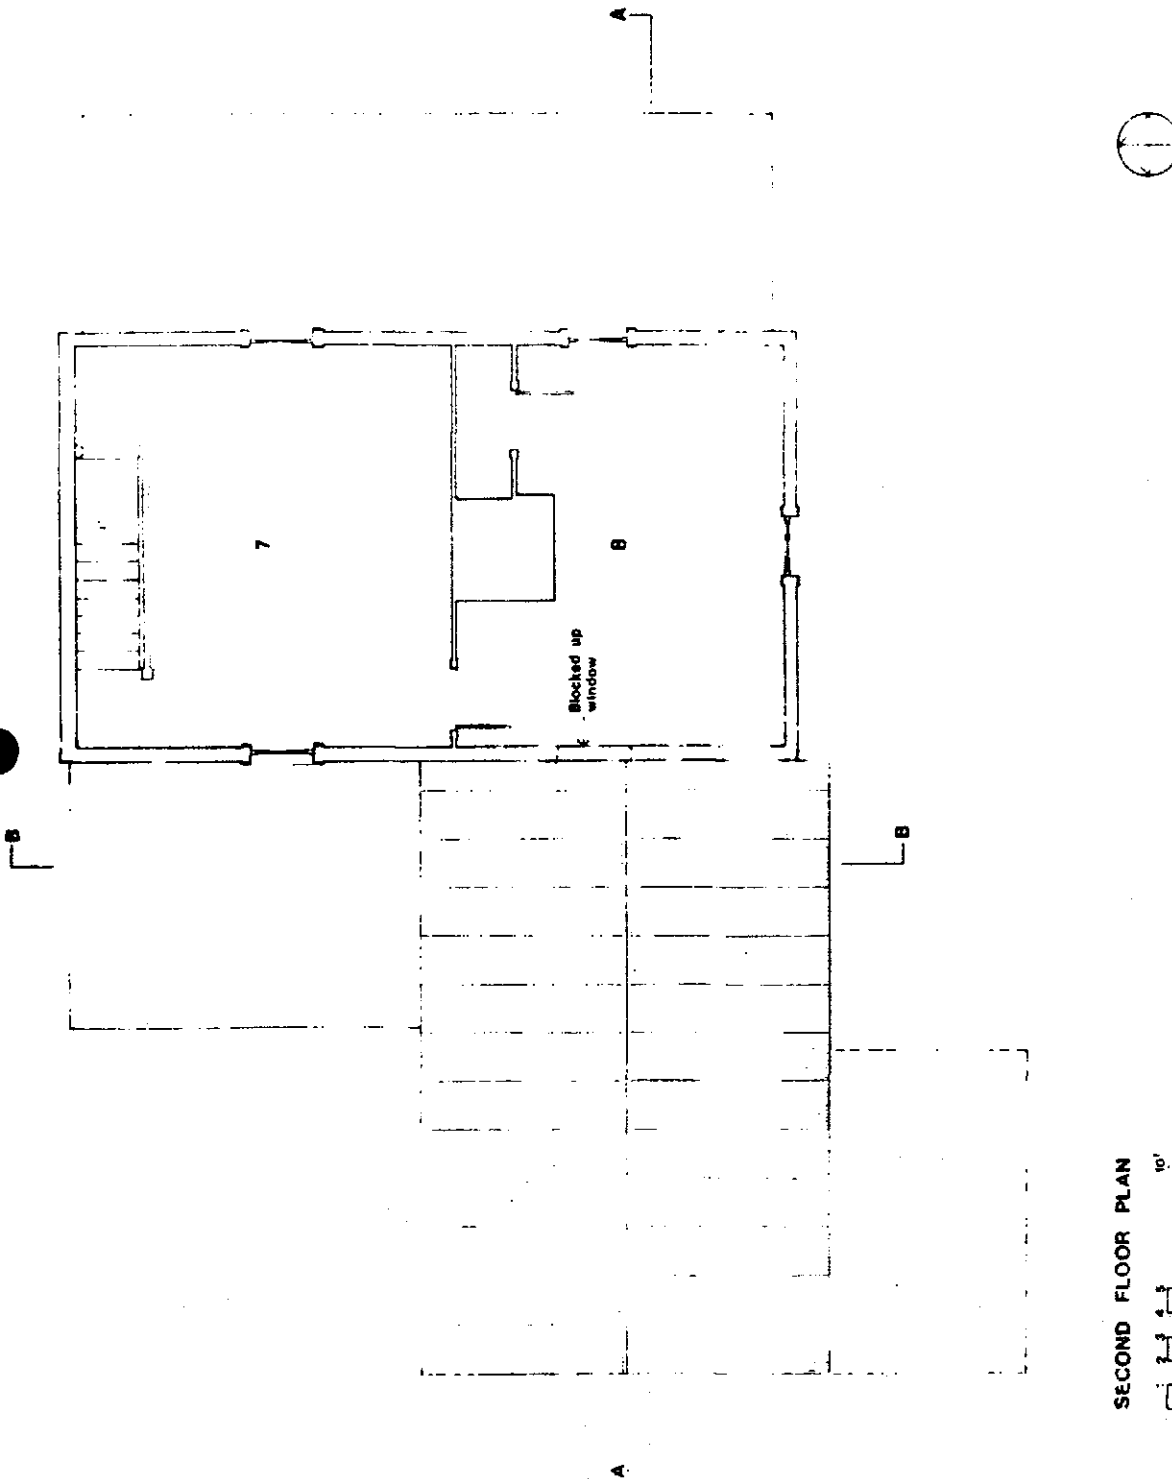
Second floor plan of the Feeney dwelling.

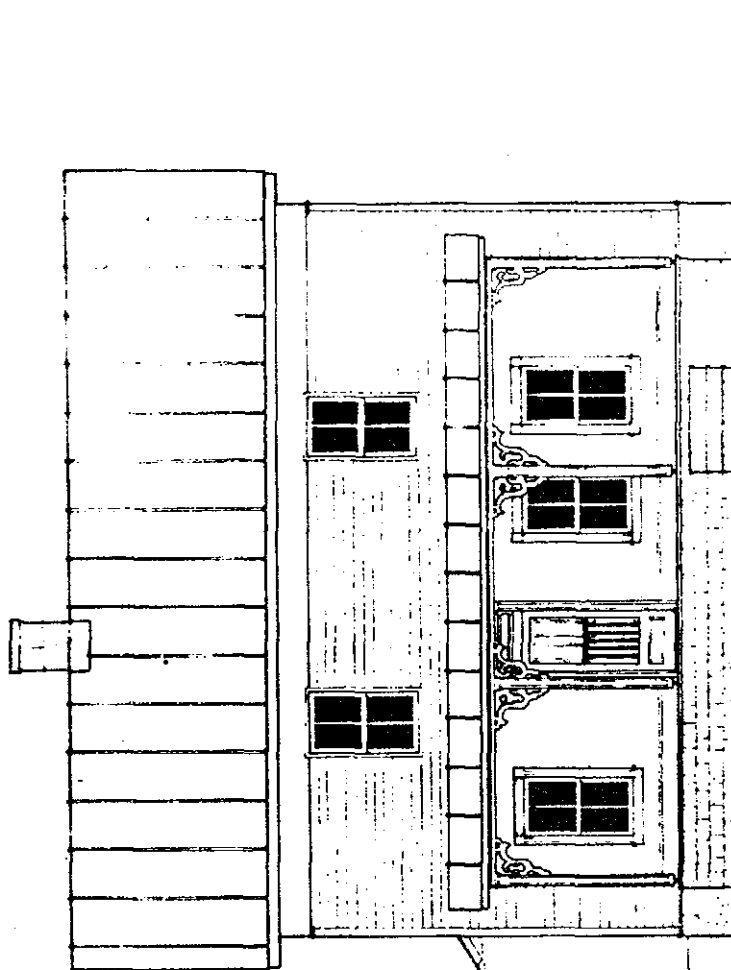
EAST ELEVATION

East elevation of the Feeney dwelling.

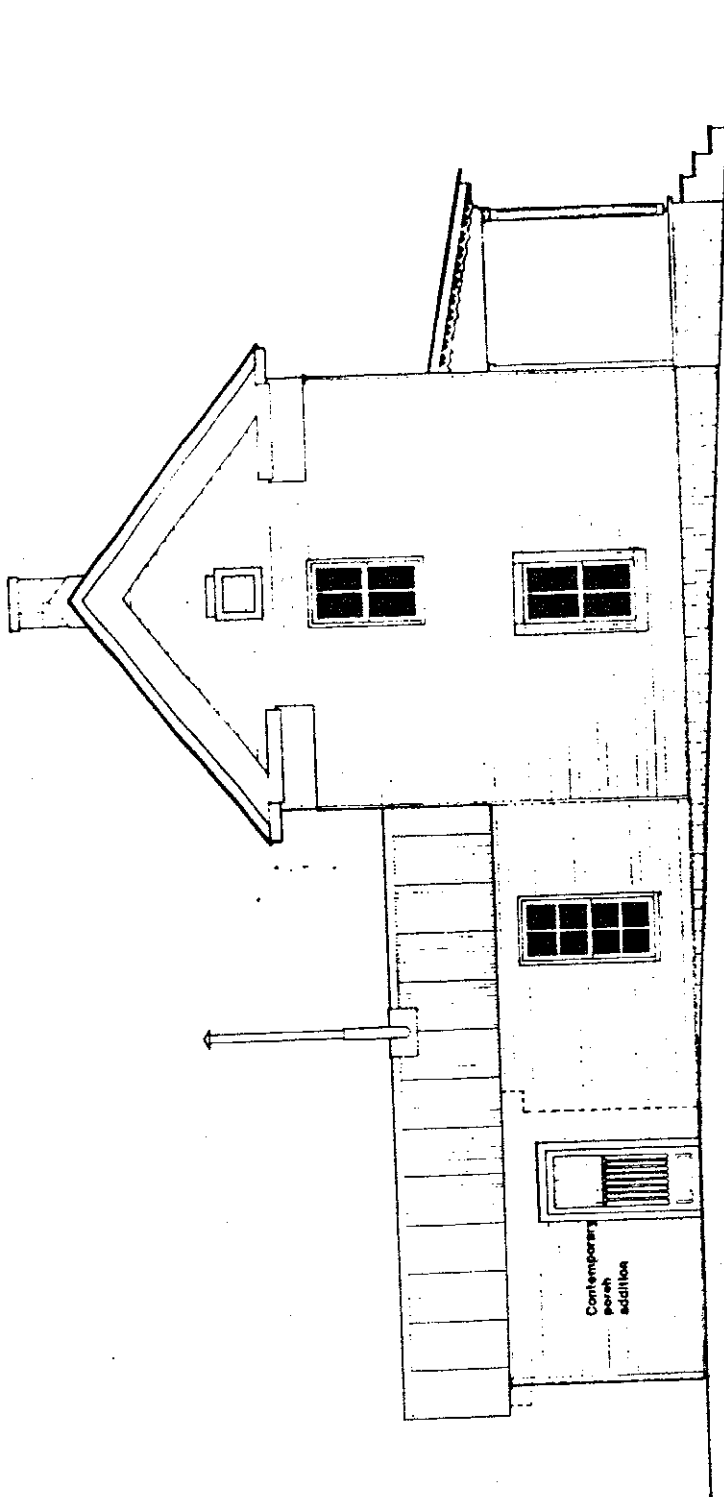
SOUTH ELEVATION
1 2 3 4 5 10'

South elevation of the Feency dwelling.

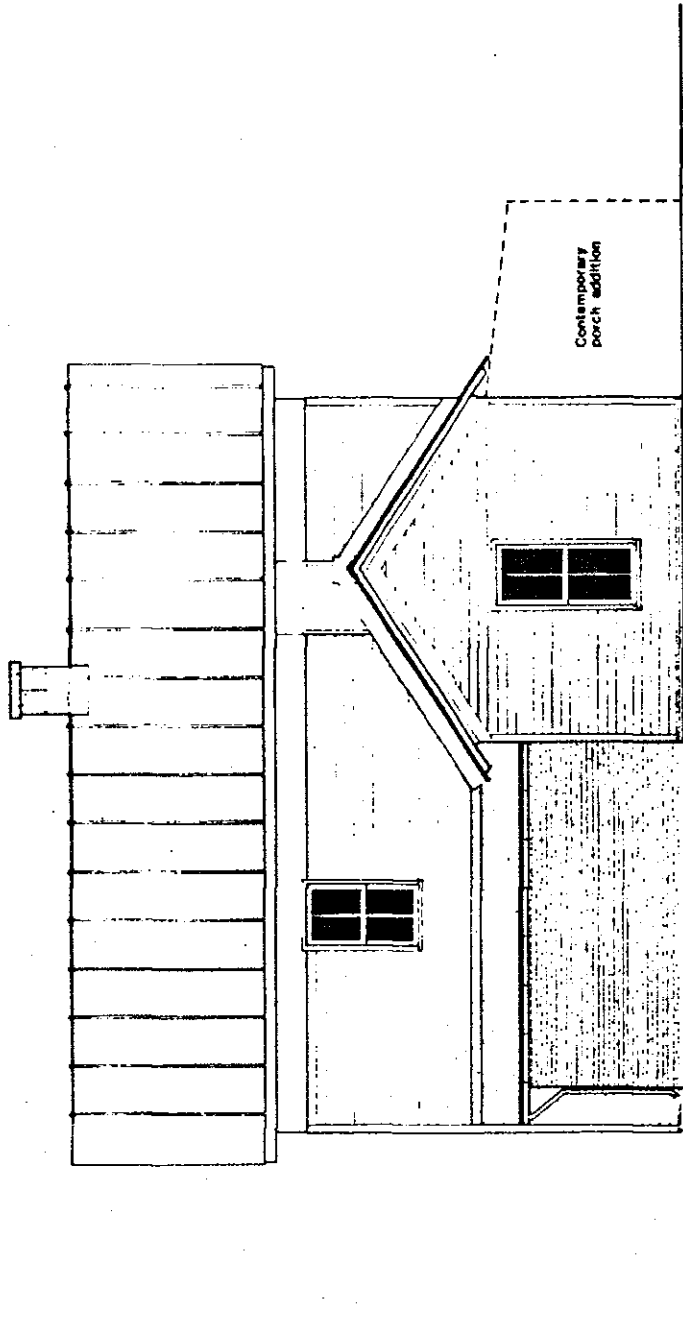
WEST ELEVATION

West elevation of the Feeney dwelling.

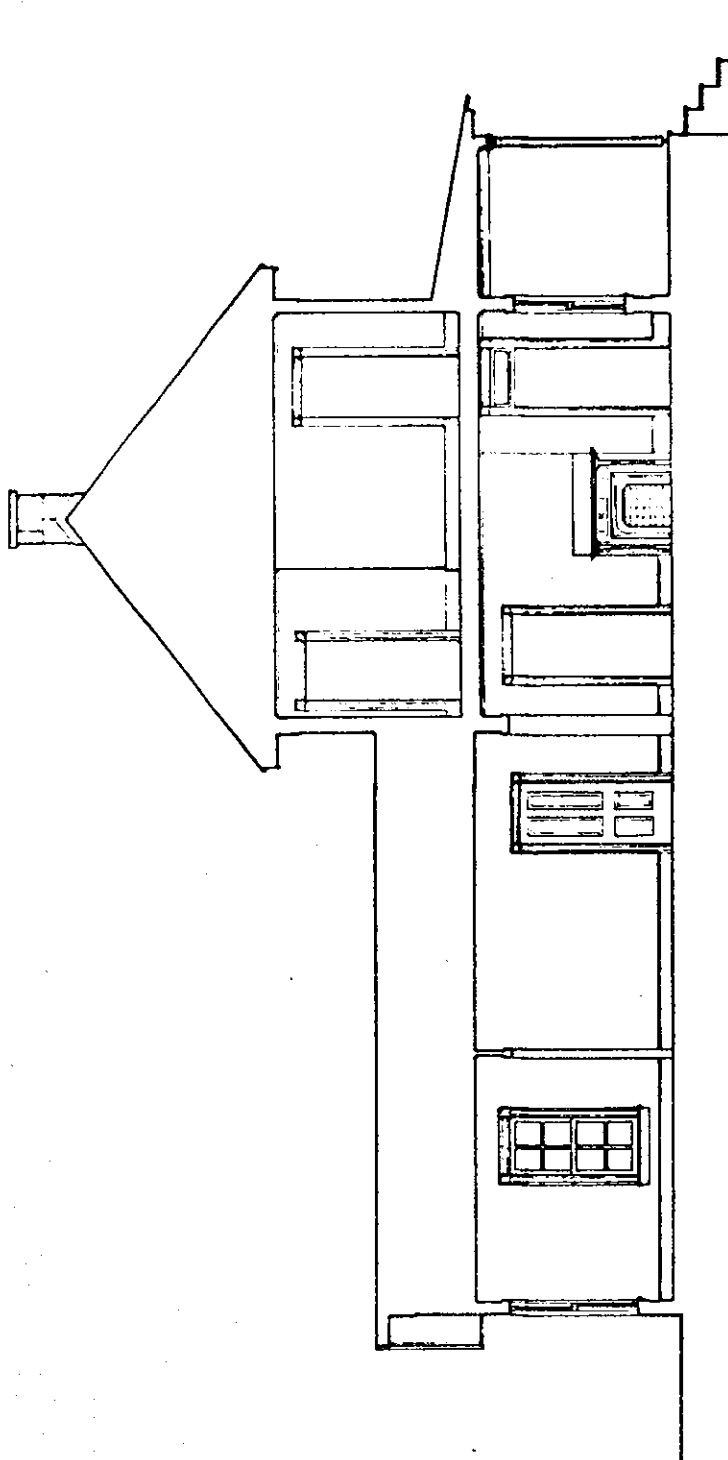
SECTION A-A
1" = 12'

Longitudinal section (A-A) through the Feeney dwelling.

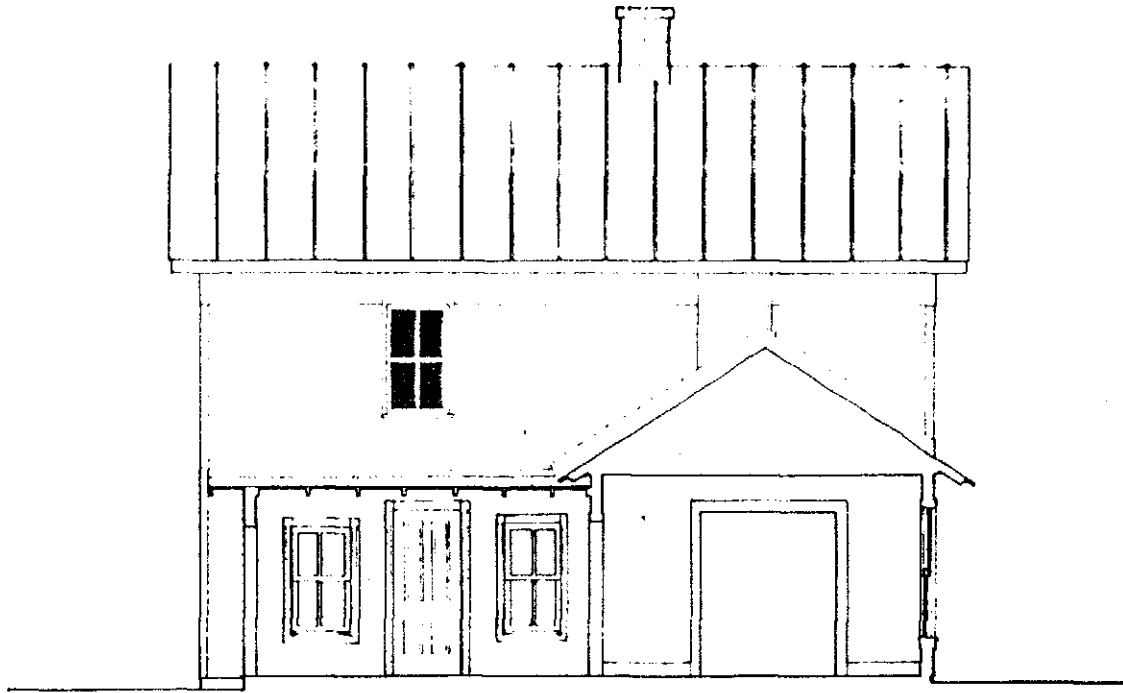
SECTION B-B

Transverse section (B-B) through the Feeney dwelling.
